ION ROCKET SYSTEM RESEARCH AND DEVELOPMENT

QUARTERLY REPORT

20 September 1964

ELECTRO-OPTICAL SYSTEMS, INC.

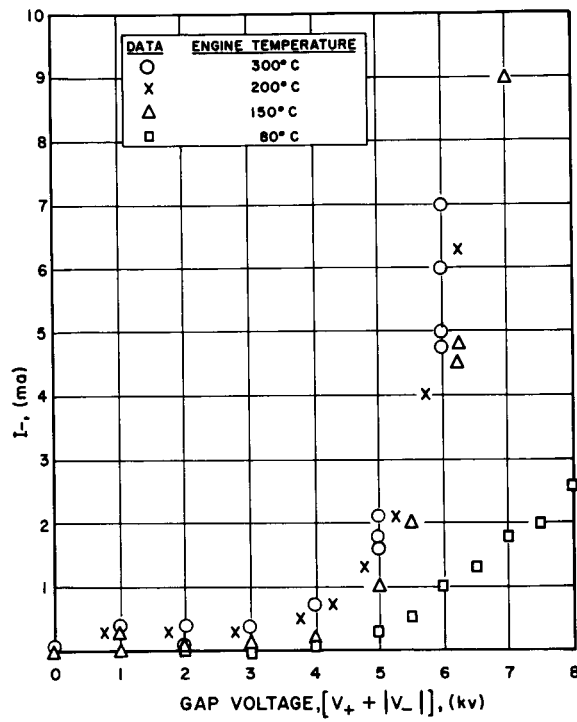
FIG. 1
RESIDUAL DRAIN CURRENT
VS GAP VOLTAGE

After the 23 hour test was terminated, high voltage was turned back on and the drains were measured as a function of accelerator gap voltage as the engine cooled. The results are shown in Figure 1. The temperatures were measured at the engine shell and are only roughly indicative of the screen electrode or accelerator electrode temperatures. The drain current - gap voltage relationship is highly non-linear and suggests a field enhanced emission effect although the temperatures and the magnitude of the field in the gap are much too low to give these phenomena for cesiated molybdenum.

Although the Malter effect may play a role, the main mechanism is probably field enhanced thermionic emission or the Schottky effect. Anomalities introduced by "patch effects" lead to the anomalous Schottky effect in which the current-voltage relationship may be such as that observed in Figures 1 and 2.

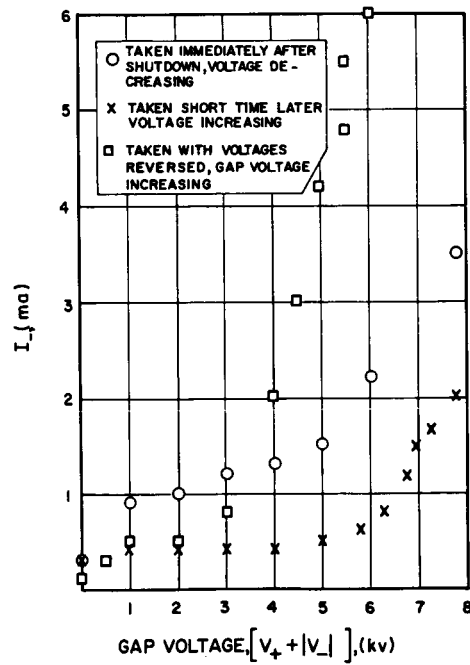
FIG. 2
RESIDUAL DRAIN CURRENT
VS GAP VOLTAGE FOR TWO
POLARITIES

After a long cooling period, the engine was restarted and after several hours high drains were again encountered. The feed system and arc power were removed and the data of Figure 2 were taken. For the two sets of data taken for normal polarity, the differences in the data are partly due to cooling of the system but there does appear to be a significant hysteresis effect. The voltages applied to the electrodes were then reversed and the third set of data was taken. The higher current for this case is significant as it indicates that the electrode surface effect giving rise to the drain current is more pronounced on the screen electrode than on the accelerating electrode. Since the screen electrode runs hotter and presumably stays hotter than the accelerating electrode during the time both are cooling, the higher current with reversed polarity is consistent with an electron emission hypothesis.

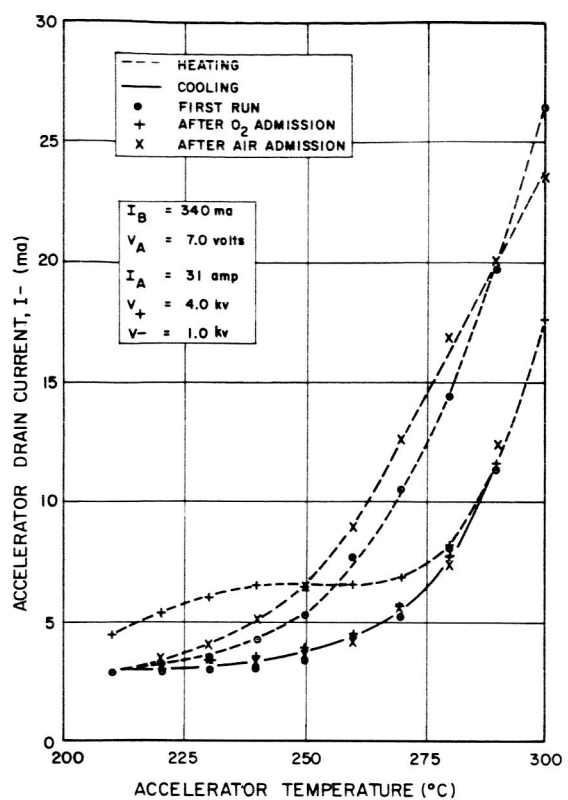
FIG. 3
TEMPERATURE AND OXYGEN
DEPENDENCE OF DRAIN
CURRENT

The data obtained are shown by the circled data points in Fig. 3. The apparent hystereses in the data are probably due to slow changes in the equilibrium surface conditions on the accelerator and to a temperature difference between the emissive surface and the point at which the thermocouple was attached. The length of the support arm

coupled with the heat capacity of the support insulator and shield should cause the measured temperature to lag the temperature of the electrode proper. A very strong temperature dependence is shown by the data of Fig. 3.

A third set of data was taken after air was admitted to the vacuum system in a manner similar to the previous admission of oxygen. These data are shown by the X's in Fig. 3. This curve is quite similar to the curve obtained during the first run and indicates that the electrode surface had indeed been returned to its initial condition.

After returning to the original operating level, oxygen was admitted to the vacuum system until the pressure had risen from about 10^{-6} torr to 10^{-5} torr. A slight increase in drain current was noted as the pressure increased. When the pressure reached 10^{-5} torr, the bleed valve was closed and a sharp rise in drain current was observed. The system was allowed to regain the initial conditions and the heating and cooling test was repeated. The data obtained are shown by the crossed data points in Fig. 3. This data shows a significant increase in the drain current during the early portion of the heating cycle with no hysteresis apparent in the higher temperature data. The oxygen admission had apparently increased the electron emission at the lower temperatures. The heating above about 270°C , however, seems to have returned the electrode to its original surface condition.

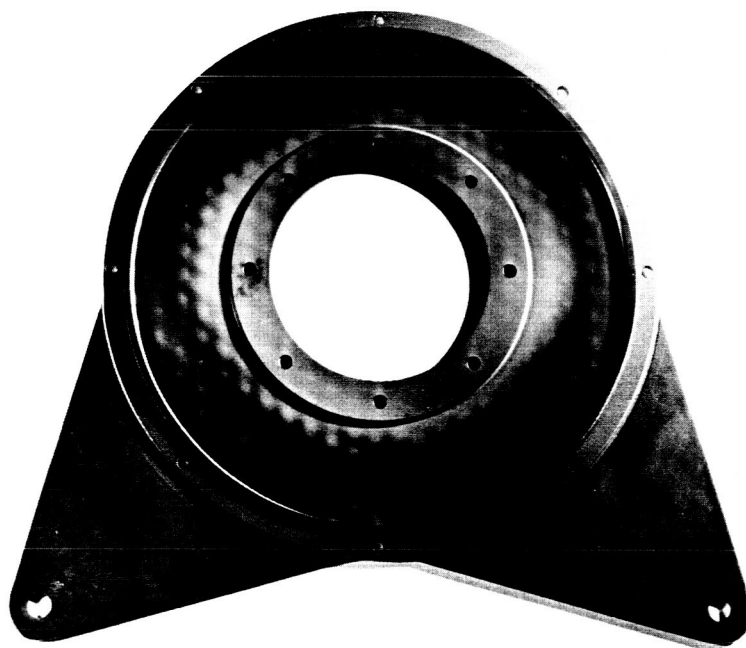
FIG. 4
CATHODE MOUNTING PLATE
AFTER HIGH DRAIN TEST

During all three tests, significant increases in cathode temperatures were measured when the drain current was high. At times, drain currents higher than 50 ma were observed. Upon disassembly of the engine, a pattern of "clean" spots was observable on the cathode plate which closely matched the electrode pattern. A photograph of this cathode plate is shown in Fig. 4. These spots are considered to be due to electrons accelerated through the screen apertures.

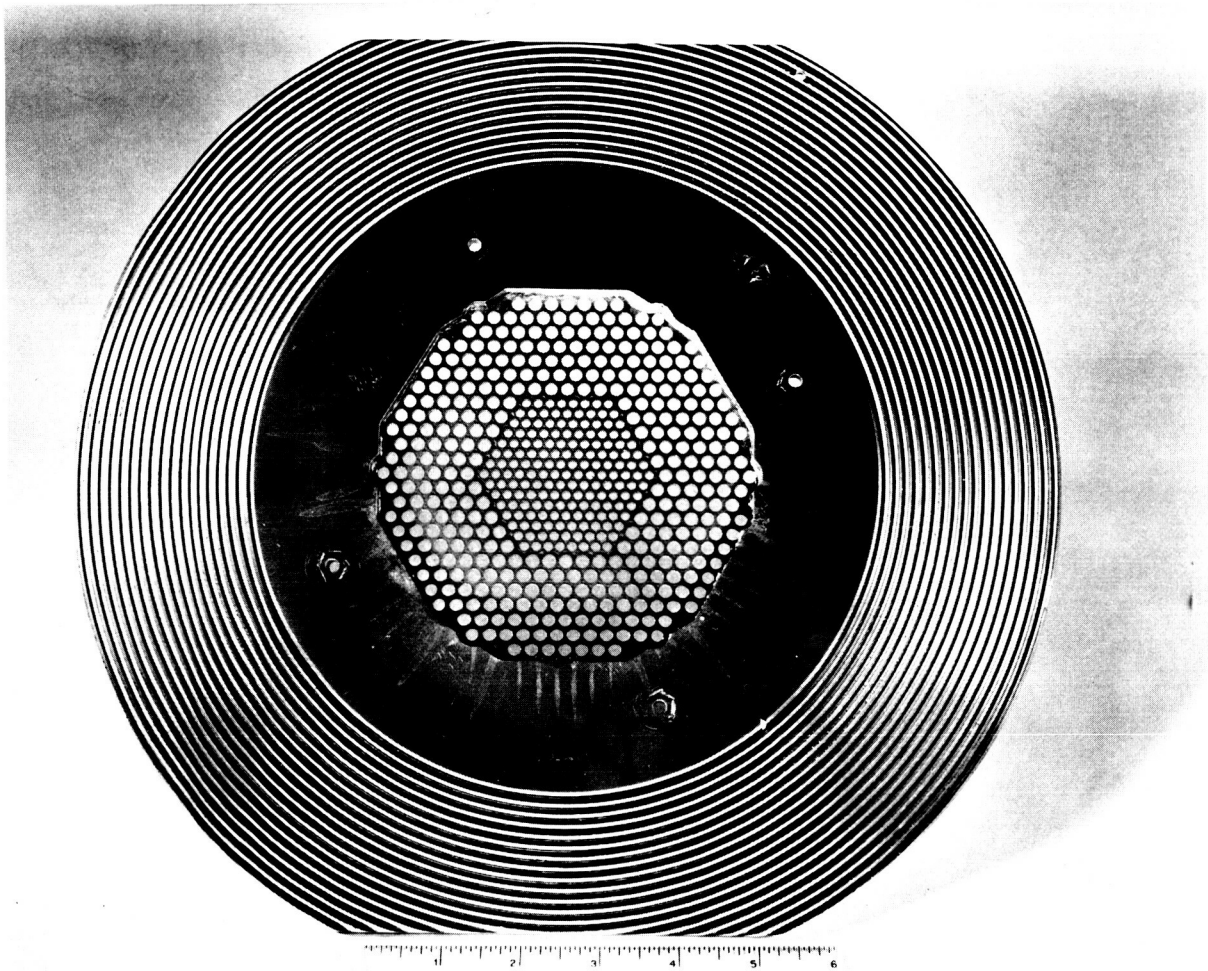
FIG. 5 COOLED COPPER ACCELERATOR ELECTRODE

The cooled copper electrode is shown in Fig. 5. It was fabricated by brazing a DE design copper accelerating electrode to a 13 inch outer diameter heavy copper fin. The large copper ring was grooved to enhance its emissivity. When operated with an engine, this electrode had a temperature of 190°C at the periphery of the aperture pattern and an estimated 200°C at the center of the electrode. Due to distortion of the copper and close spacings outside the aperture area, engine operation was very noisy with much arcing. During 16 hours of operation, however, the drain current showed no increase.

Due to its massiveness no reliable weight could be obtained for the large copper electrode. After removal from the engine a visual inspection showed very little erosion due to sputtering of the electrode. Pits were noticed on the down stream side similar to damage noticed on other runs but the depth of these did not exceed a few mils.

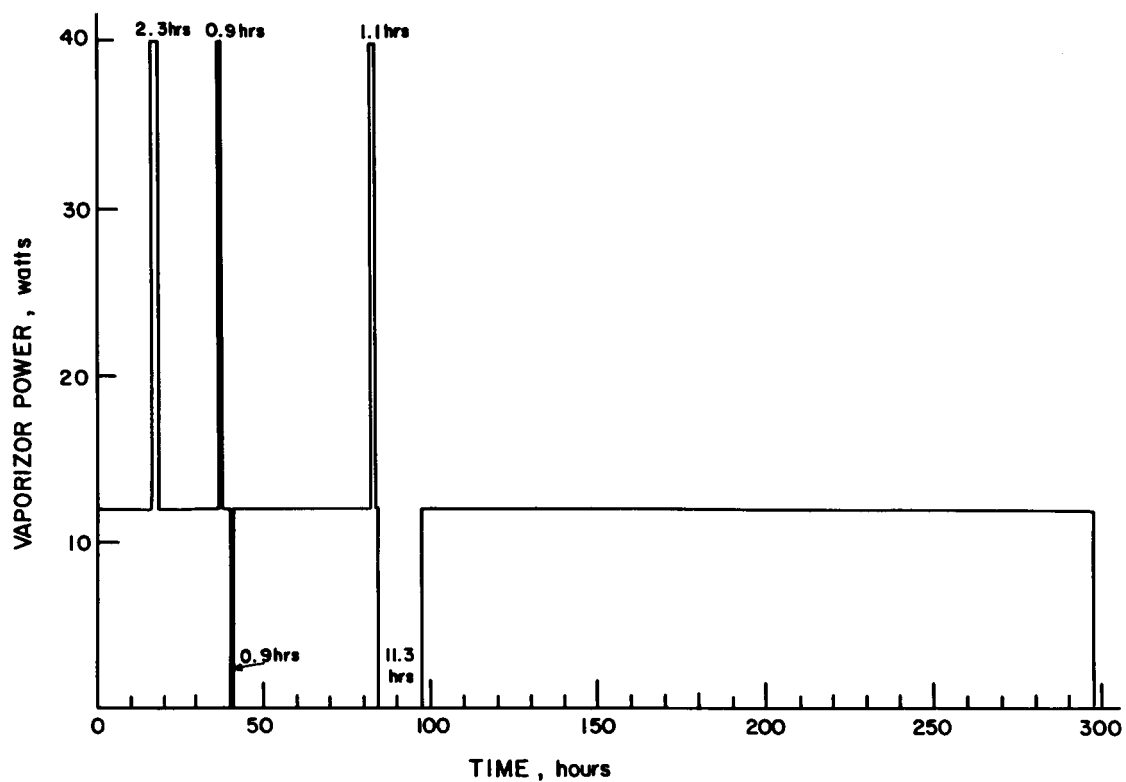
FIG. 6 VAPORIZER POWER HISTORY FOR 281 HR TEST

The vaporizer power history of the test is presented in Fig. 6. During the first 86 hours there were five interruptions due to high

voltage overload circuit and cycling circuit malfunctions. Three of the interruptions resulted from a high voltage cycling relay sticking in a mode that kept high voltage turned off and provided a full beam demand signal to the feed control system. Consequently, during these off-periods, the vaporizer power was on full. Two of the interruptions were deliberate in order to attempt to fix the circuit components. During this phase the longest uninterrupted period of operation was 42.1 hours and the total accumulated operating time was about 80 hours. The test then proceeded with a 201 hour uninterrupted run. The total accumulated operating time was about 281 hours. The test was terminated on 7 August, 1964 with the engine operating normally. The drain current fluctuated about 2.5 ma but there was no significant increase other than in the residual insulator leakage current.

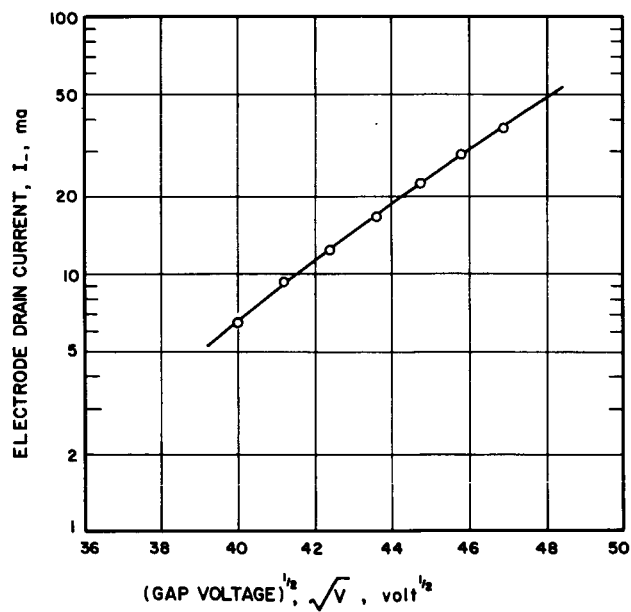
FIG. 11 SCHOTTKY PLOT FOR REVERSED VOLTAGE TEST

Extrapolation of the Schottky plot indicates a thermionic current requiring a work function of less than 1.2 ev. The Cs-O-Mo composite surface appears to exist on the molybdenum screen electrode.

The field between flat parts of the screen and accelerating electrodes is on the order of 10,000 volts/cm at 2.2 kv across the gap. The slope of the Schottky plot requires a field over 100 times more intense. Perhaps the field at the sharp edges of the apertures in the screen electrode are large enough to account for the large Schottky enhanced emission. The downstream sides of the apertures were not radiused.

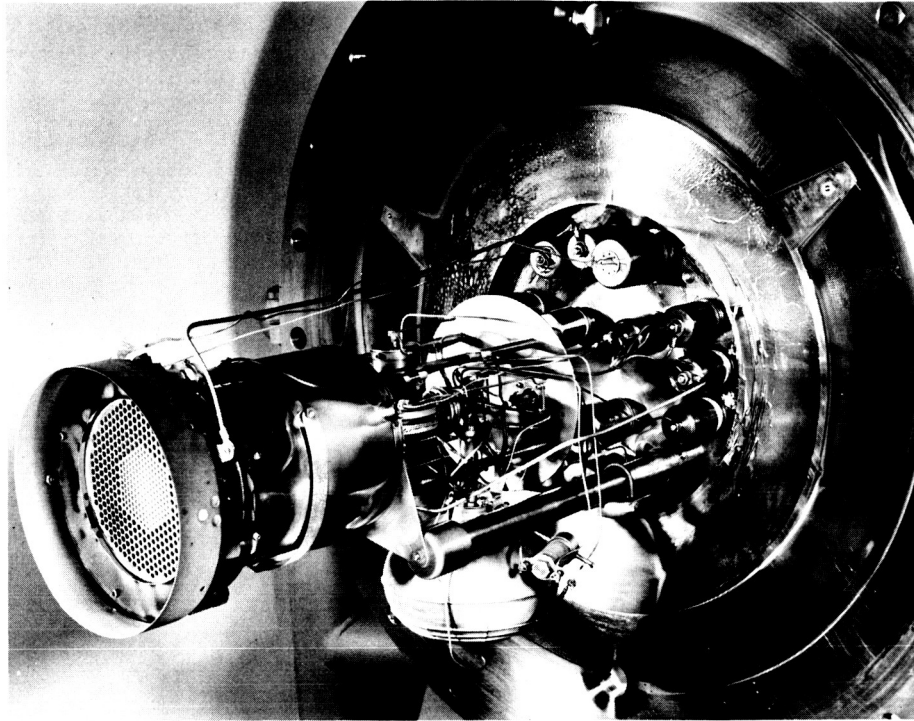
FIG. 12 DER-1 ENGINE SYSTEM AFTER 281 HR TEST

A pictorial record of the system and components immediately after the run can be seen in Figs. 12 thru 19. The engine system, shown in Fig. 12, was extremely clean. Only copper (on areas facing the collector) was visible upon inspection. Figure 13 is a view of the inside of the cathode and orifice plate. They both appeared in excellent condition. A light deposit was found on the first two coils next to the baffle (see photo) which appeared to be either residue from impurities in the propellant or from the braze compound. Unfortunately, not enough of this substance could be obtained to be analyzed.

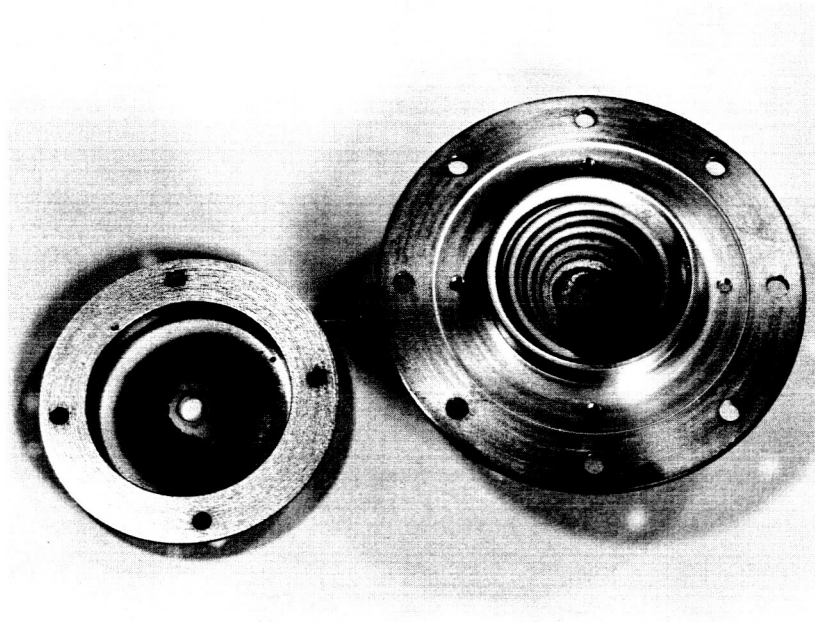
FIG. 13 CATHODE AND ORIFICE PLATE

There was a non-uniform heating pattern on the orifice plate. A similar off-center, light area was found on the up-stream side of the accelerator electrode. This condition has been noted before. The clean area at the cathode is due to electron heating. Since the clean areas on both parts are in line with each other it would appear that the emission was occurring from the clean spot on the electrode.

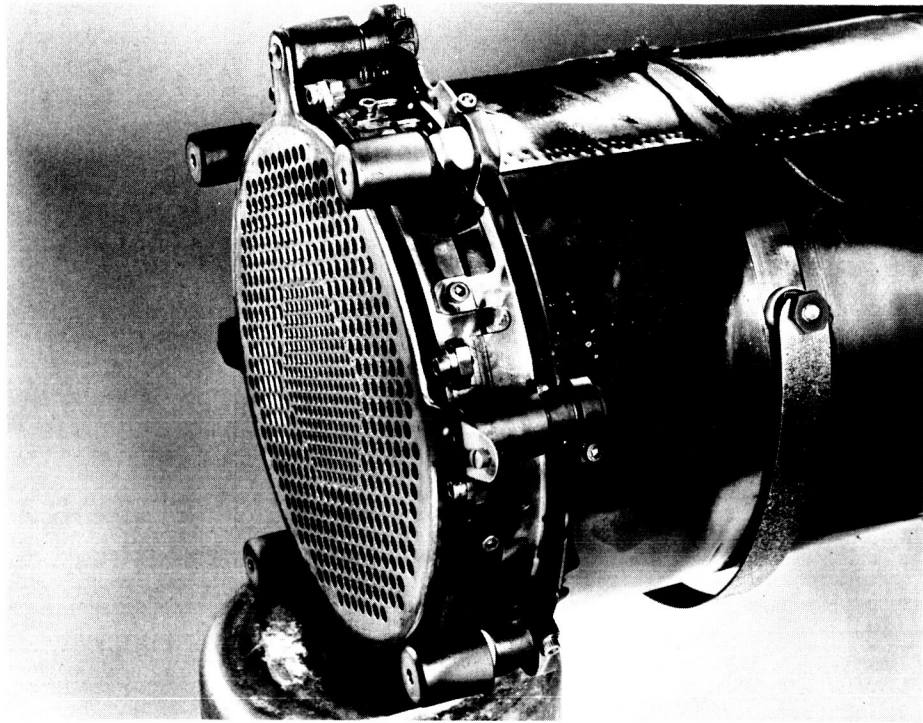
FIG. 15 ENGINE SHELL

The most severe damage to the engine occurred on the outer shell (magnet cover) where electron bombardment had worn through the .003 inch thick titanium sheet. This might have damaged the magnet coils had the run continued. Careful inspection of Fig. 15 reveals one of these thin spots on the lower front cover. It would appear that some electrons from the beam plasma were focused to these spots.

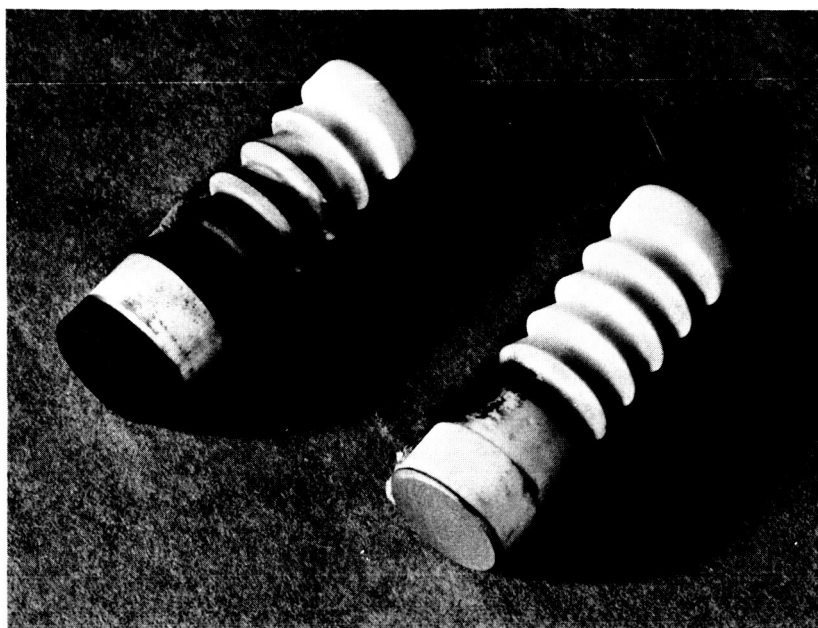
FIG. 16 INSULATORS

Figure 16 indicates the condition of insulators after the run. They appeared relatively clean under the shielded area although localized dark rings could be found in the troughs of the convoluted surfaces. In general the hotter the running temperature, the cleaner the surface. Unshielded parts of the insulators were contaminated.

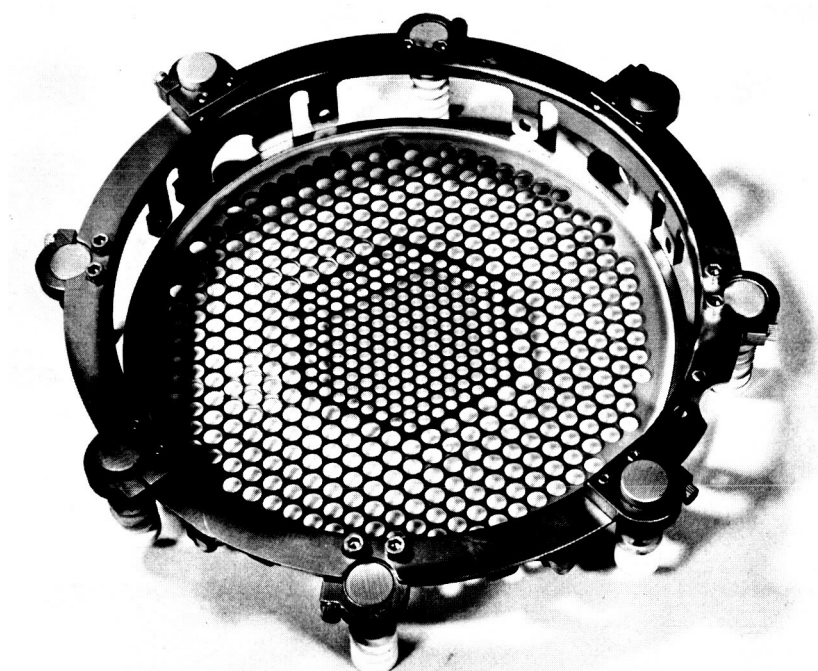
FIG. 17 SCREEN ELECTRODE

The screen electrode was discolored but no visible erosion was noted. Figure 17 is a view of the electrode assembly showing the upstream side of the screen. Note the discoloring in the grid portion and the metallic appearance of the outer edge of this plate. The small lip machined on these plates is successfully preventing cesium from escaping through this joint.

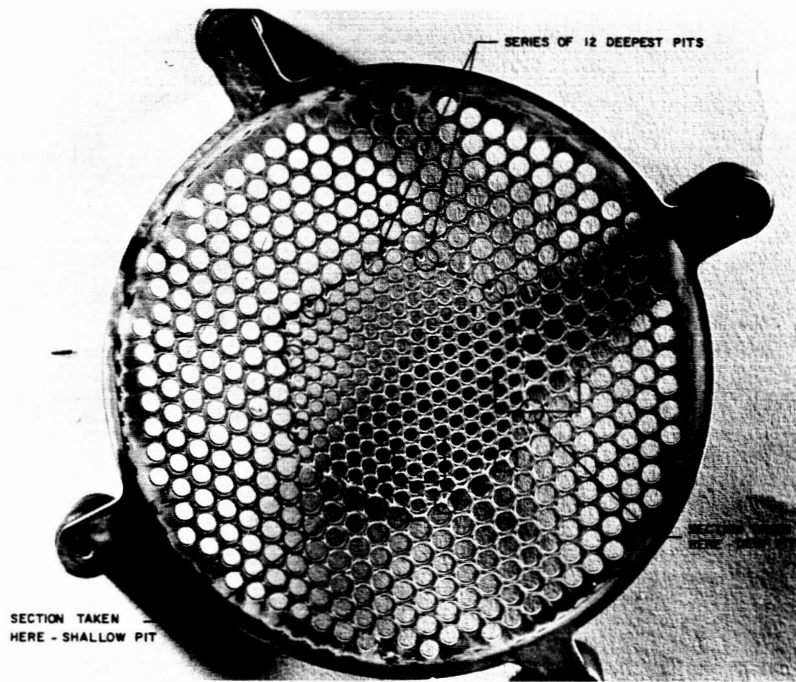
FIG. 18 ACCELERATING ELECTRODE - DOWNSTREAM SIDE

Copper deposited on the downstream side of the electrode was .00062 inch thick. The estimated weight of this layer is 1.1 gm.

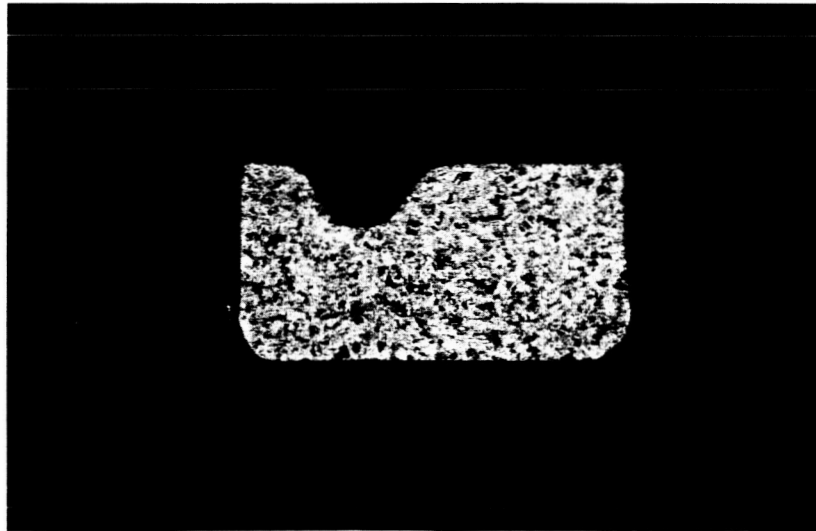
FIG. 19 CROSS SECTION OF DEEP PIT

Depth of pits in the small hole pattern ran from .0048 to .0139 inches with the deepest holes nearer the outer part of the pattern. Pits in the large pattern ran from .0099 inches at the inside of the pattern to no pits at the outer edge. A photo-micrograph of one of the shallow pits appears in Fig. 20. Figure 21 shows the upstream side of the accelerator electrode. There was no visible erosion.

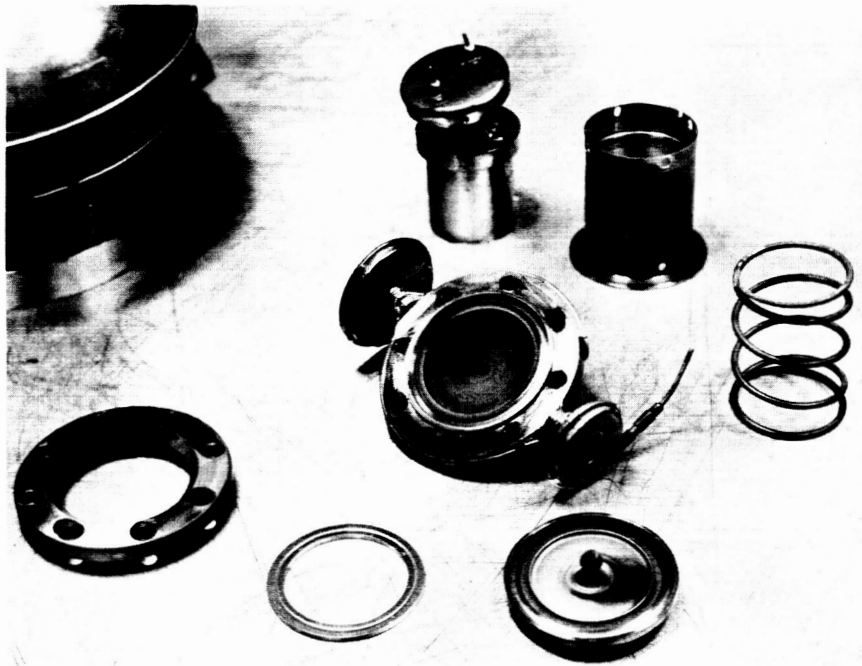
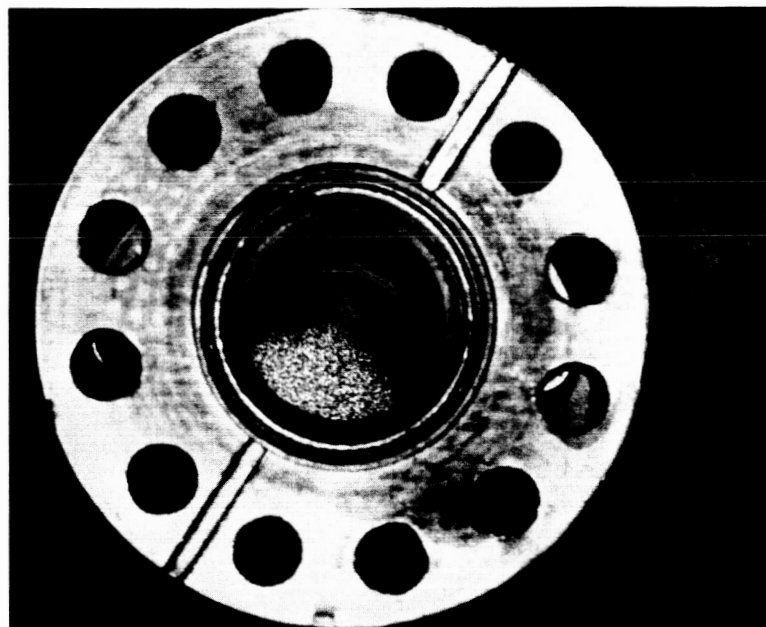
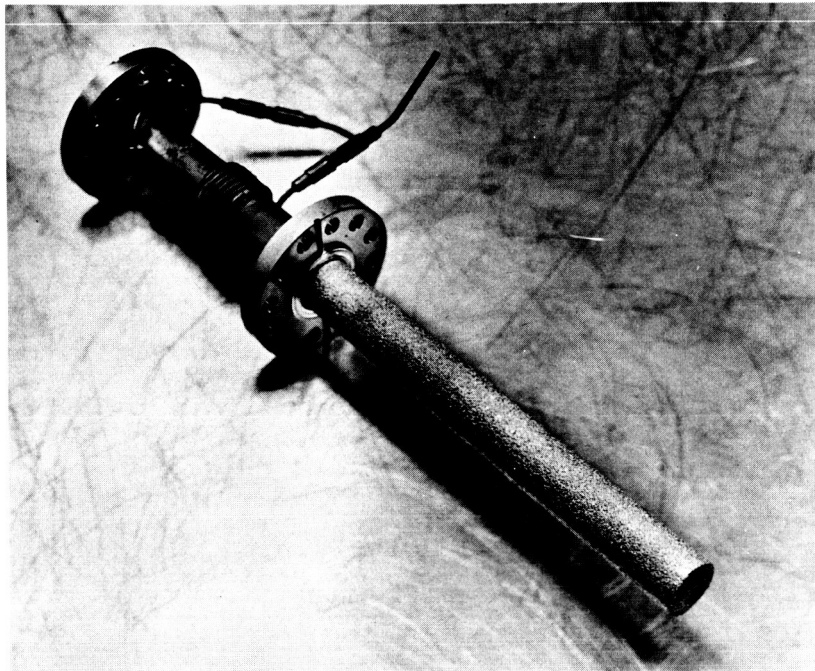
FIG. 22 FEED SYSTEM COMPONENTS

Following the 281 hour duration test, the zero-g feed system was completely dismantled and an analysis made on many of the components. The feed system was disassembled in the dry box. The photographs of Figures 22, 23, and 24 show the components of the system while still in the dry box. It was observed that the cesium both in the reservoir and on the porous rod was clean and bright. Slight discolorations were noted in the vaporizer tube and on the valve body. The valve ball contained a small deposit of material. Analysis of this deposit disclosed copper, gold, and silicon as the contaminants. Sectioning of the reservoir showed it to be exceptionally clean inside with no evidence of cesium corrosion or attack at weld joints or on the fin assembly.

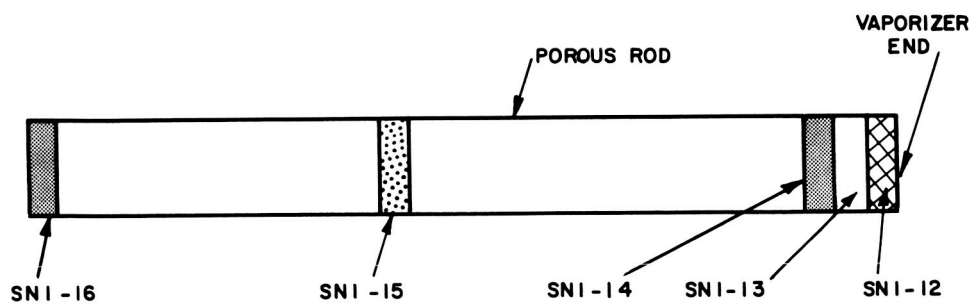
FIG. 25 LOCATION OF SAMPLES TAKEN FOR ANALYSIS

The porous rod was sectioned while still in the dry box. Five samples were removed for analysis. Figure 25 indicates the location on the porous rod where samples were removed. Table IV lists the results of the quantitative spectrographic analysis that was performed on these samples. Included in this table is the analysis of a control sample which was removed from the same porous rod prior to the engine run.

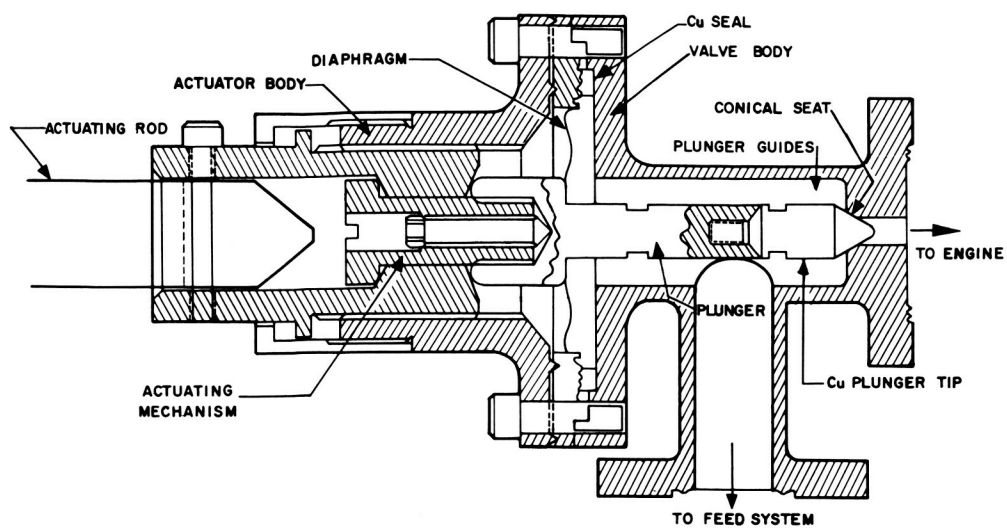
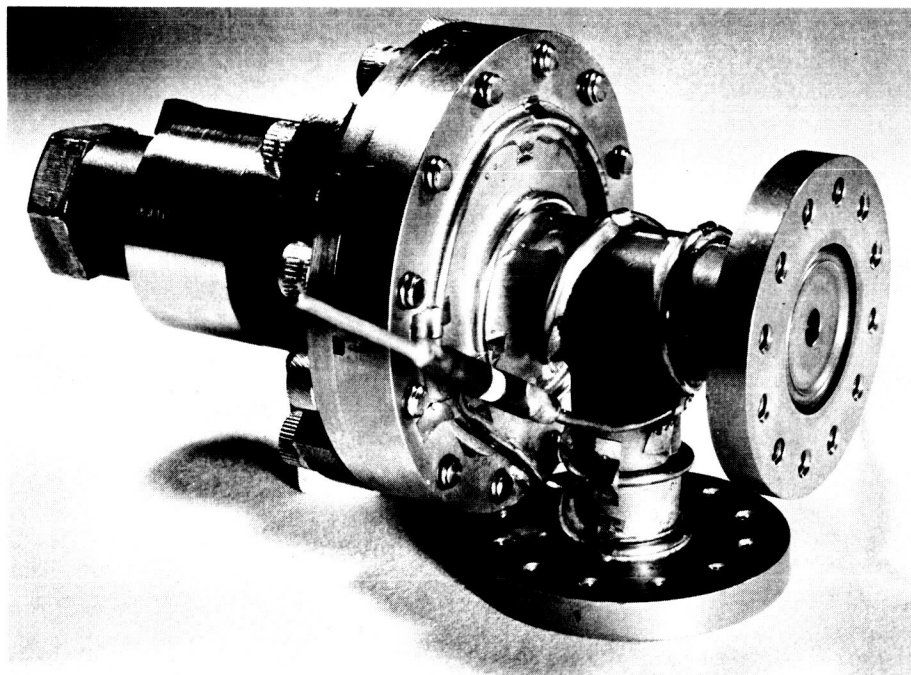
FIG. 26 MANUALLY OPERATED CESIUM VALVE

A mechanical cesium vapor valve was designed and fabricated during the quarter. It is for use in place of the existing solenoid valve on the DER engine system. Its purpose is to provide a reliable leak-tight valve for laboratory testing. Some interesting features of the valve which is shown in Figures 26 and 27 are described below. The valve consists of three sub-assemblies; the valve body, the poppet assembly, and the actuating mechanism. The valve body is fabricated of type 347 stainless steel and heated with a sheathed heater. Its mass is considerably less than the mass of the solenoid valve which is currently being used. It is expected that heat-up times will therefore be considerably shortened.

The poppet assembly consists of the valve poppet which is welded to a metal diaphragm similar to that used on the solenoid valve. The only seal used in the valve is between the body and poppet assembly. The actuating mechanism is of hardened type 17-4 stainless steel. The screw mechanism is overcoated with a high temperature solid-film lubricant to minimize friction. In addition, thermal isolation is provided between the actuating assembly and the valve body to minimize heat conduction to the actuating assembly.

Actuation of the valve is provided by a retractable rod which is introduced through the vacuum flange. An O-ring assembly on the flange prevents leakage at the flange. Since the rod is retracted when high voltage is applied to the engine, there is no need for electrical isolation of the rod.

Testing of this valve had included helium mass spectrometer leak checking and room temperature cycling. Twenty successive actuations were made with no detectable leak across the valve. The detector used has a sensitivity of 10^{-10} std cc He/sec. Actuating torque during this test was held constant at 25 inch-pounds. The valve was assembled to a feed system and cesium flow tested at valve body temperatures up

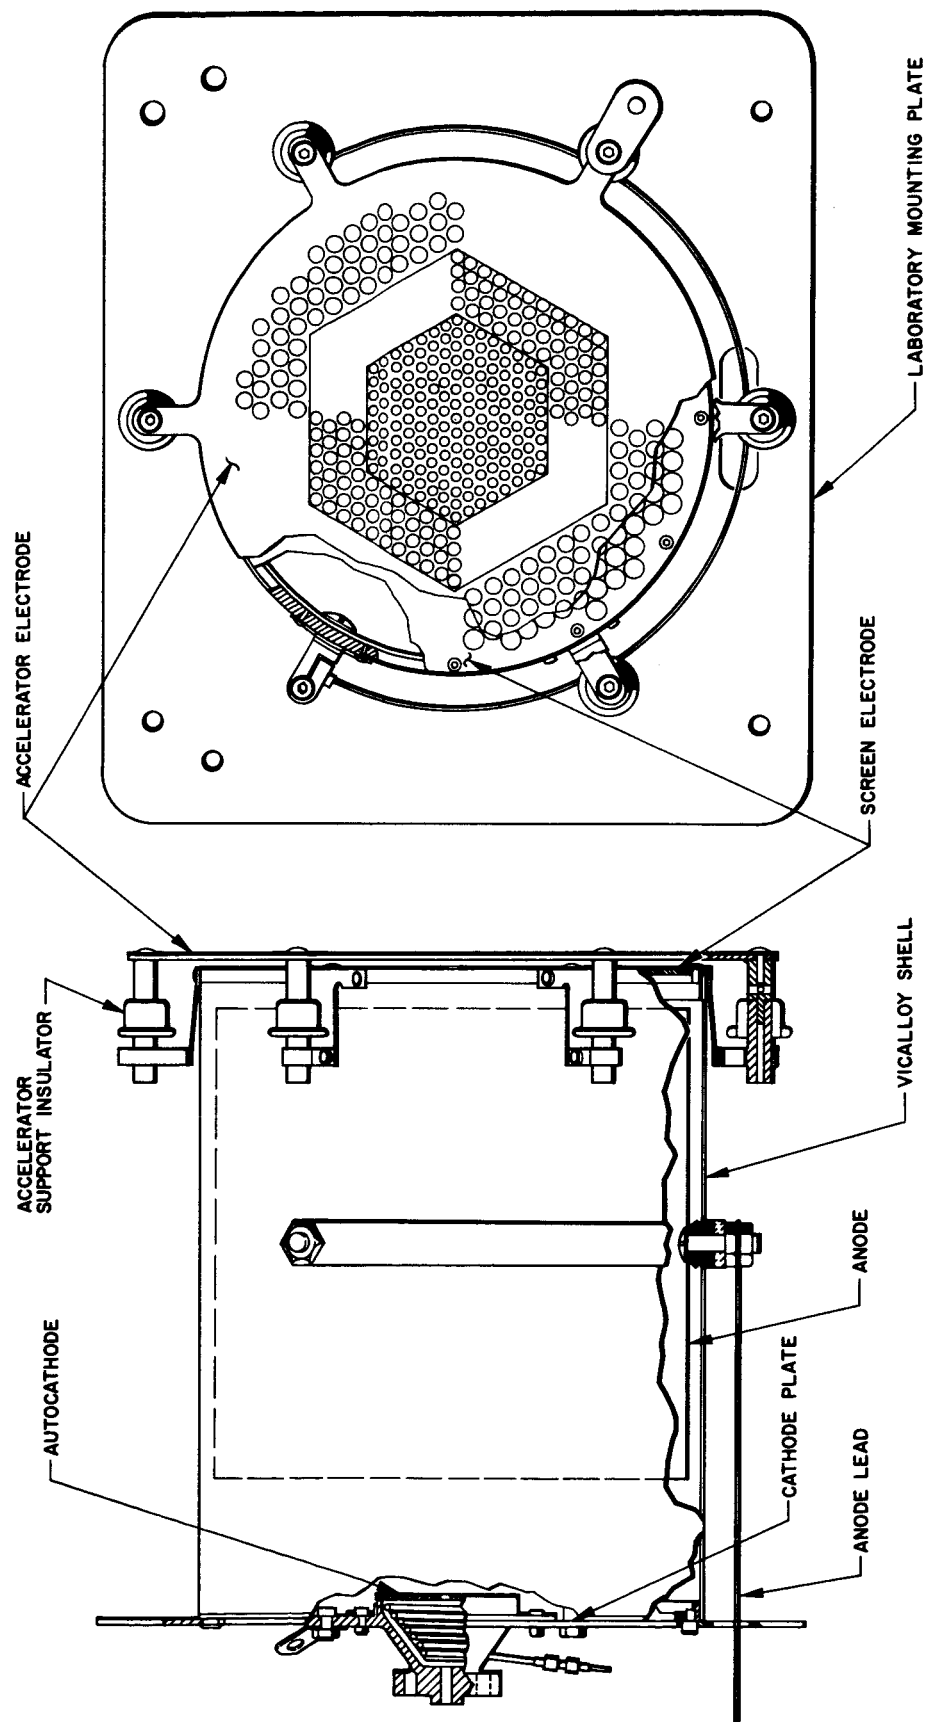
FIG. 29 PERMANENT MAGNET ENGINE DESIGN

A new engine was designed to test the feasibility of replacing the engine shell with a cylindrical permanent magnet. Details of the design can be seen in Fig. 29. The cylinder was rolled from 0.016 inch thick Vicalloy sheet and electron beam welded to two iron rims. The cathode and anode are similar to the DE design. The accelerator support insulators were mounted further from the electrode gap and were attached to the front rim of the shell by flexures which allow free radial displacement. A higher thermal impedance between the shell and the accelerator was used than on the DE design.

The screen electrode and cathode plate were made from pure iron to form the pole pieces of the magnetic circuit. An intermediate hole pattern was used between the central and peripheral patterns. This was done to alleviate the sudden change in ion-optics noticed on the DE engine and reported in the next section of this report.

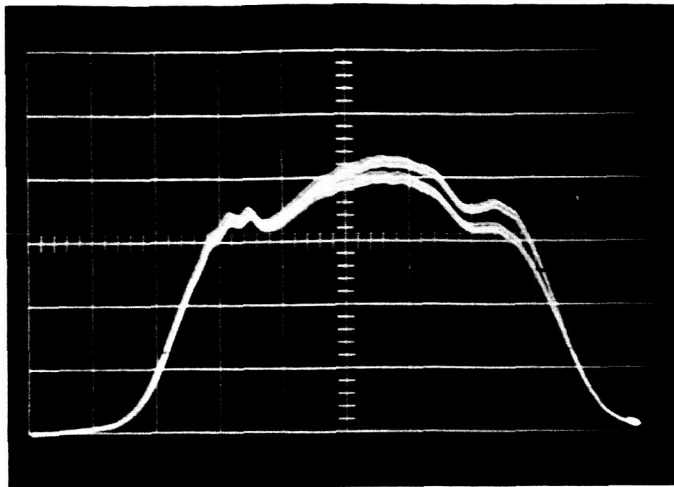
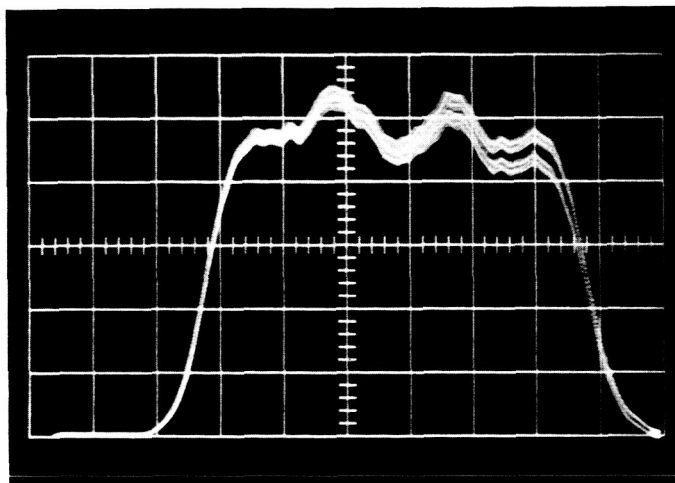
(a) DE Engine with permanent magnets

Ion efflux distributions were measured for the permanent magnet modification and electromagnet versions of the DE engine. These are shown in Fig. 31a and 31b respectively. These figures are photographs of oscilloscope traces with the vertical deflection proportional to the probe position. The dip near the edge of the curves is caused partly by the small area free of apertures at the radius where aperture sizes are changed. The main reason, however, for the dip appears to be the change in focussing and collimation of the ion efflux across the aperture size transition region. The dip in the center of the

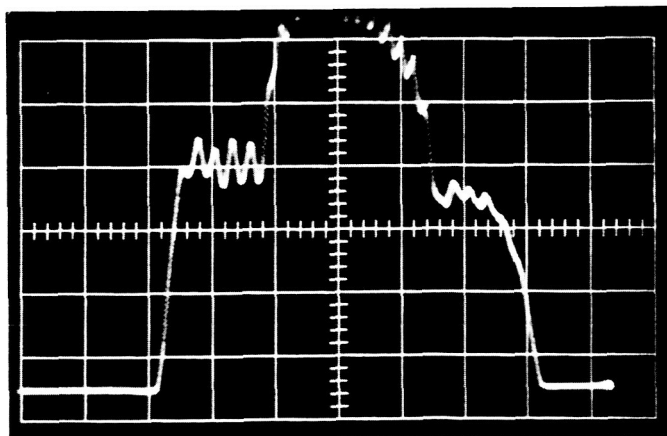
(c) DE Engine

Figure 31c is an ion efflux distribution measured from the DE engine using a collimated Faraday probe. Collimation was obtained by adding an additional aperture to the probe. This probe measures only those ions which are exhausted along the axis of the probe and has a very small angular acceptance (~ 2 degrees). The integral of the observed distribution over the area of the engine is therefore only a fraction (about 20 percent) of the total ion beam. Information obtained with this probe is strongly dependent upon focussing as can be seen in the curves of Figures 32, 33, and 34. These curves were obtained in the same manner as those of Fig. 31, using the collimated probe. The two sides of the curves were averaged to eliminate a slight skew which was present due to probe misalignment.

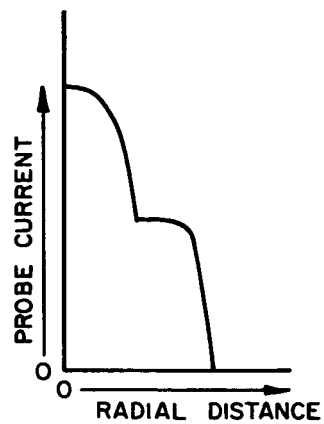
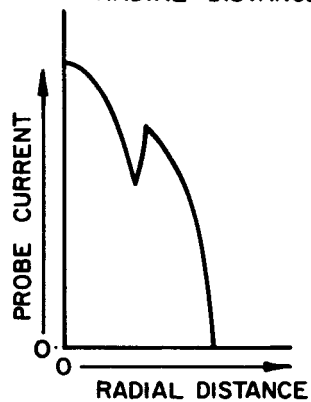
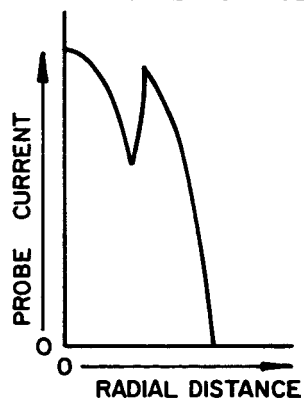
FIG. 32 VARIATION OF ION CURRENT DENSITY DISTRIBUTION WITH SOURCE POTENTIAL

Figures 32 and 33 show the effect of variations in source potential and accelerator electrode potential respectively. From the three curves of Fig. 32 it appears that the higher the source potential the better the focussing. High source potential, however, tends to make the change in ion optics more drastic across the transition between the two hole patterns used. Figure 33 indicates that the closer the accelerator electrode potential is to ground potential, the better the focussing. This is expected since the decelerating region downstream from the accelerator electrode slows the exhausted ions in the axial direction but does not greatly affect transverse velocities. Thus, for a given trajectory to the accelerator (constant current and accelerating gap potential) higher decelerating potential drops will increase the angle between the exhausted ion and the engine axis. This probe may allow more thorough evaluation of the ion optics of various electrode systems than was previously possible for the gas discharge engines.

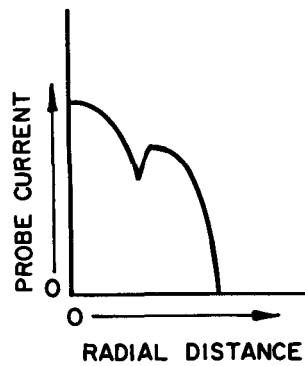
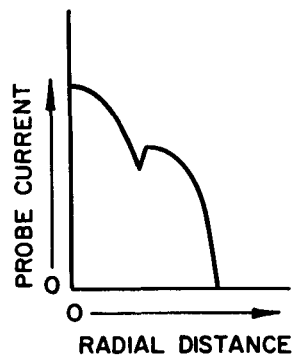
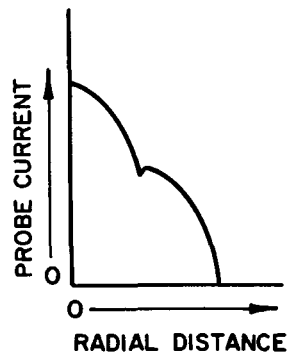
FIG. 34 VARIATION OF ION CURRENT DENSITY DISTRIBUTION WITH MAGNETIC FIELD

Figure 34 shows ion efflux profiles obtained with different values of magnetic field. As previously reported, the higher magnetic fields cause the distribution to peak at the center.
